USAAEFA PROJECT NO. 78-18

**ARTIFICIAL ICING TEST CH-47C HELICOPTER
WITH FIBERGLASS ROTOR BLADES**

FINAL REPORT

JULY 1979

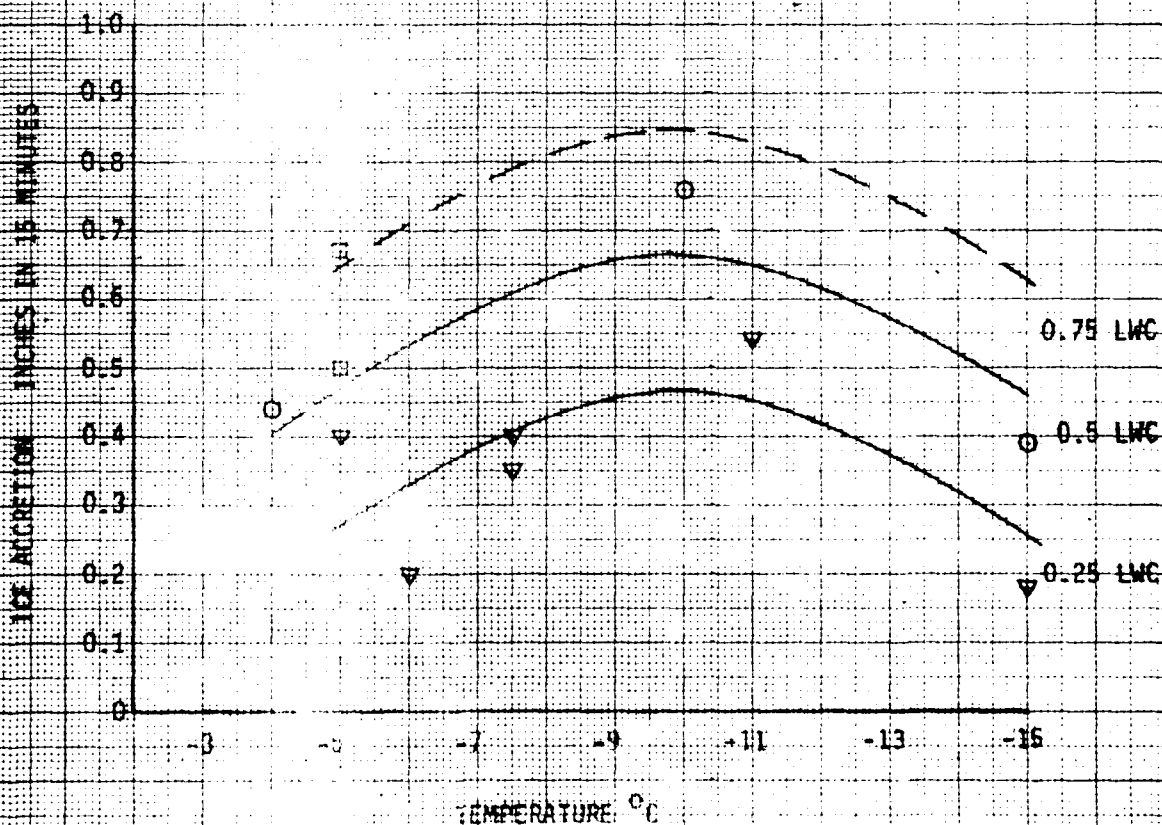
18. Figure 1 presents the average ice accretion in 15 minutes as a function of outside air temperature (OAT), for values of constant liquid water content. The ice accretion rate was determined from data recorded from the three ice detectors (See appendix D). Data for this plot were taken from tables 1 and 2 which, in turn, were derived from in-flight data. There are five natural icing test conditions and three unheated and three heated test conditions in an artificial icing environment. Although figure 1 does not take into account all parameters which may affect ice accumulation such as relative humidity, cloud cover, water droplet size, varying airspeeds, or artificial and natural environment (photos 1 and 2, appendix E, show a comparison of artificial and natural icing on the CH-47C), the data does indicate specific trends. The data show that ice accretion was greatest at approximately -10°C with colder or warmer temperatures yielding less ice accumulation. Additionally, other factors being equal, a higher liquid water content resulted in higher ice accumulation. Correlation of actual ice accretion on the cockpit OAT probe (photo 1, appendix E) with predicted ice accretion from the Rosemount ice detector showed good agreement. Correlation was attempted only in natural icing conditions on flights 12, 13, 18, and 19. On these flights, the OAT gage, which is readily visible from the pilot's seat (right side) indicated ice buildup which correlated closely with the Rosemount ice detector rate indication and elapsed time. Correlation of total ice accretion with time integrals of recorded Rosemount rate were also obtained with measured post flight accumulations on the landing gear, HF antenna supports, etc. An ice buildup of 1/4 inch in 15 minutes on the OAT probe is a conservative gage of light ice.

1. DATA WERE TAKEN FROM TABLES 1 AND 2 AND REFLECT ICING RATE VS TIME.
2. TEST CONDITIONS INCLUDE NATURAL AND ARTIFICIAL ICING ENVIRONMENT WITH BOTH PROTECTED AND UNPROTECTED SYSTEM OPERATION.

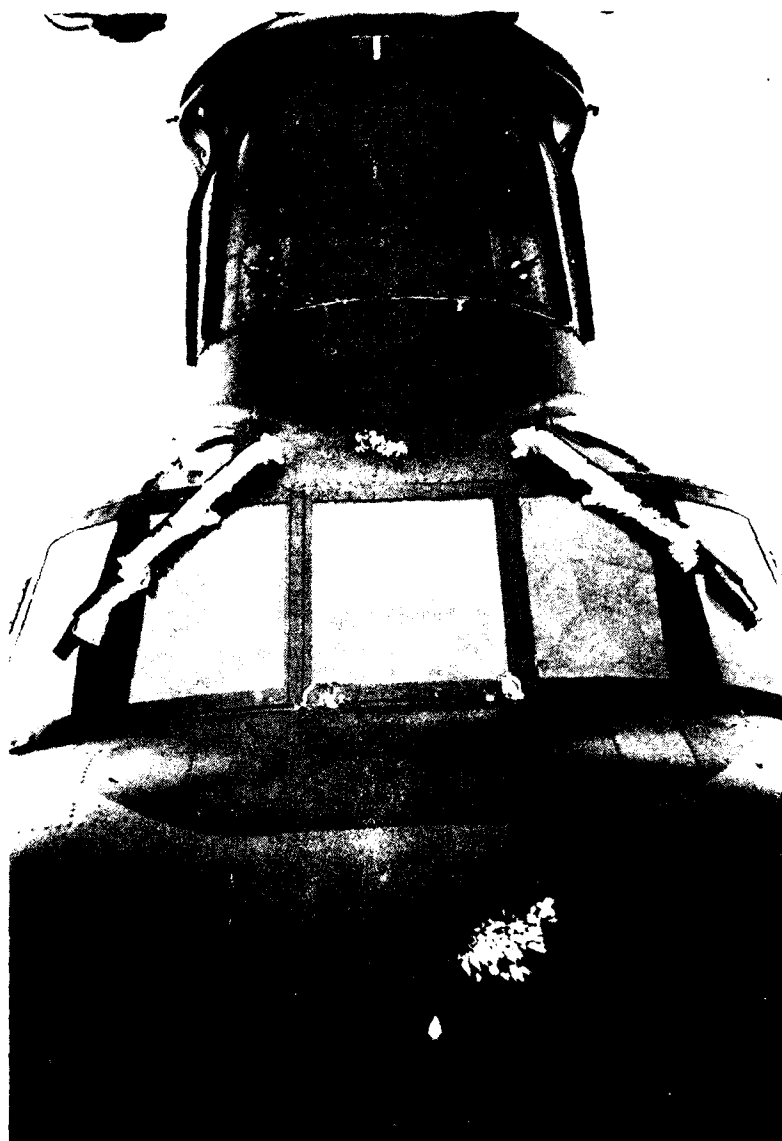
Photo 1. CH-47C Ice Accumulation from Natural Icing Environment.

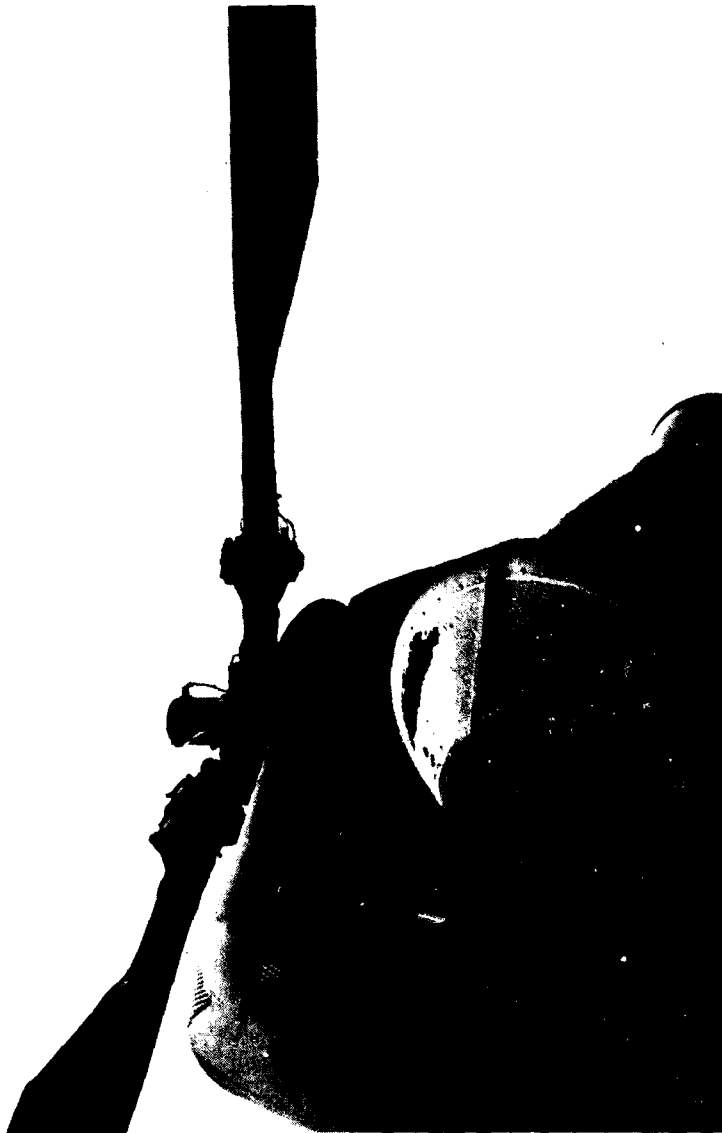
Photo 7. Engine Screen Icing.
